**SPAWNING SURVEY
ARMSTRONG CREEK, FALL
2009**

**A Report to the Happy Trout
Chapter, TUC with Notes and
Recommendations**

**SPAWNING SURVEY
ARMSTRONG CREEK, HAPPY TROUT CHAPTER, TUC**

**Prepared by
Jack Imhof, National Biologist
Trout Unlimited Canada**

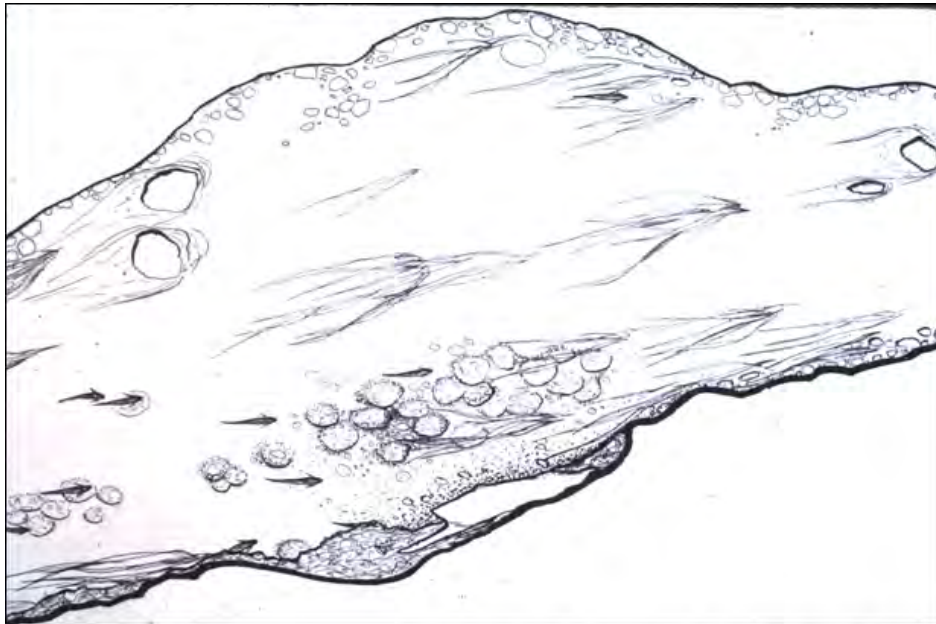
Brook trout redds are also different than brown trout redds. Rather than single large scars that are found in riffles and measure (on average) approximately 1-1.5m long, brook trout redds are found in slower water and are more circular shaped depressions cut into the stream bed (see Figure 1)

Figure 1: Demonstrating typical brook trout spawning redds (multiple circular depressions) in streams. Note that individual pairs tend to spawn side by side (illustration by G. Mercer).

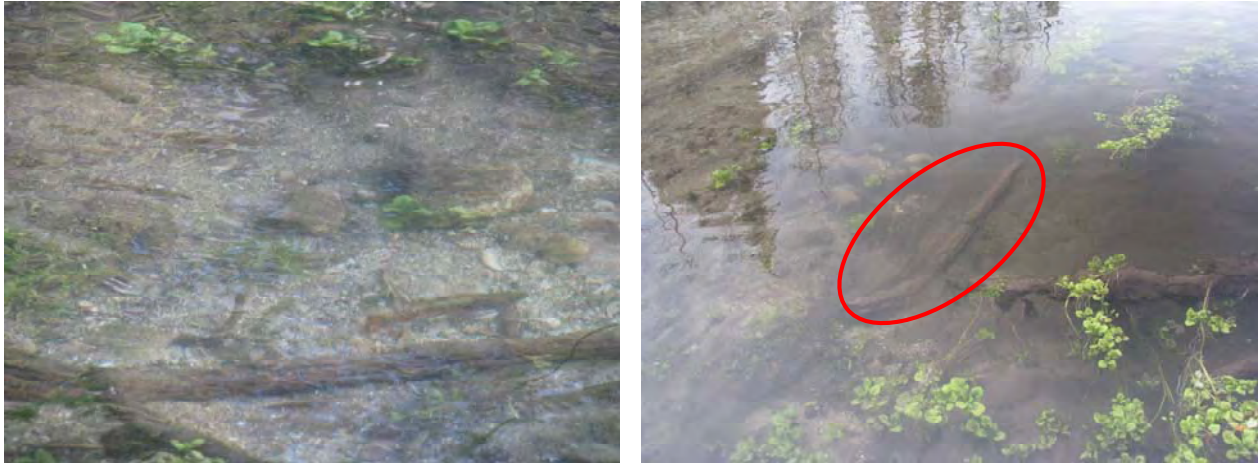
The stream did not contain any sign of frazzle or anchor ice despite the cold temperatures. The original spawning area identified on Nov. 16th no longer exhibited

evidence of spawning (no clearly identified cleared area or fish in the immediate area). Figure 2 compares the same spawning site observed on November 16th and on December 8th. The site is now covered with fine organic muck which might hinder incubation and successful hatch of the eggs placed in this location (Figure 3).

Figure 2: Spawning location with trout on Nov. 16th compared to same location during spawning walk, Dec. 8th (circled in red). Note that you no longer can see evidence of spawning.

There was some discussion about restoration work upstream that could be done to provide sufficient current to keep this area of the pool clear of fine silt in order to increase the potential for successful recruitment. This work will need to be done very carefully in order to move sufficient current to keep the fine muck off this location, while not creating a high current area through the section.

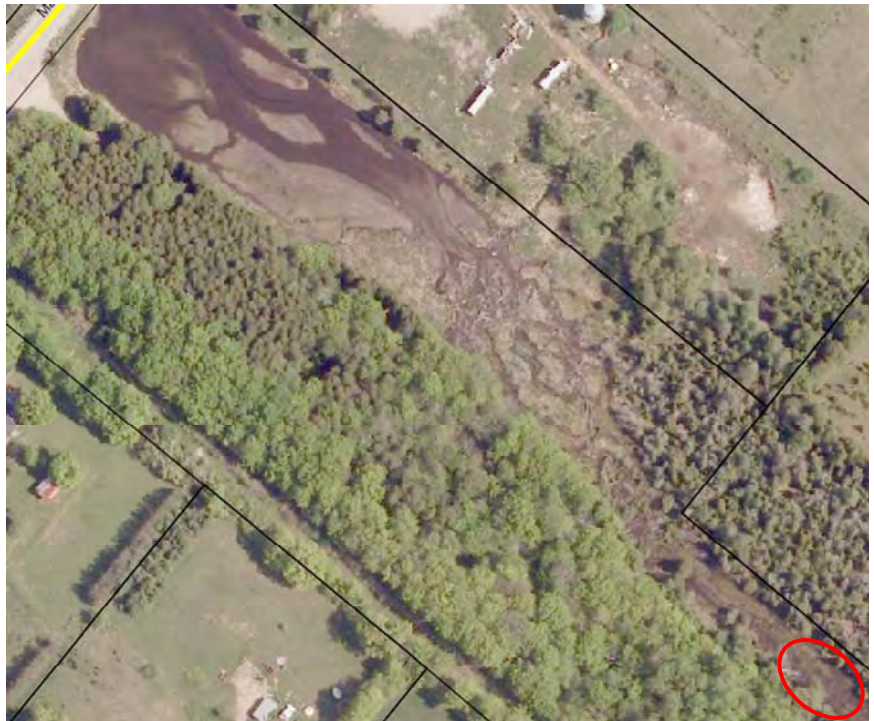
Figure 3: Air photo showing old Thompson Pond and spawning location upstream of Grey Rd. 12, circled in red.

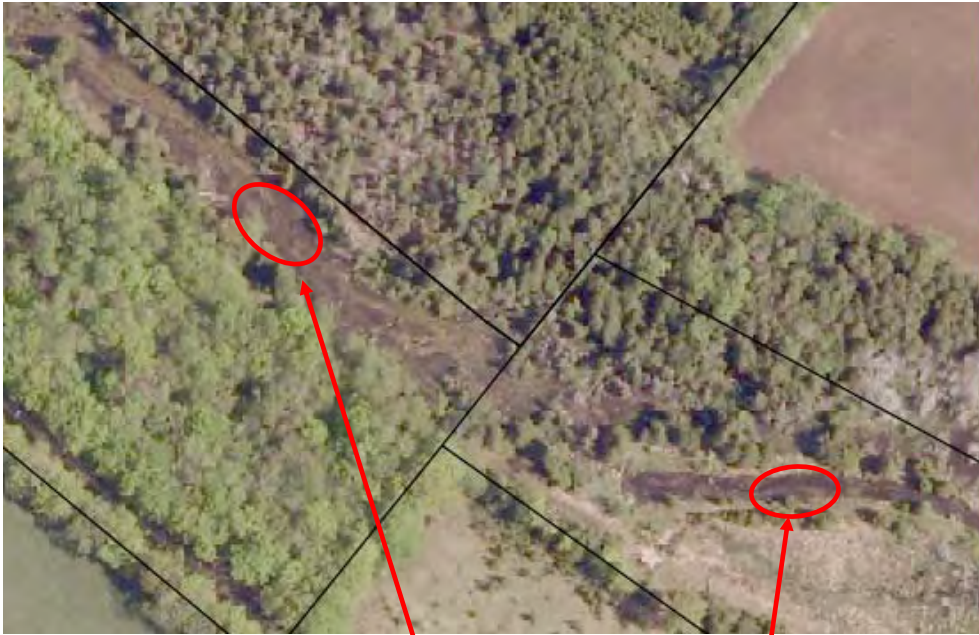
One or two additional redds were noted upstream of the first spawning site (see comparison between first and second location in Figure 4). Both on November 16th and on December 8th, a small congregation of brook trout was noted in the water intake channel, just upstream of the

water intake pipe (Table 1). A small spawning area was noted at this site though other spawning activity may have already been covered up by fine organic muck moving through this section.

Figure 4: Air photo showing first spawning site upstream of Grey Rd. 12, circled in red and second site on water intake canal upstream..

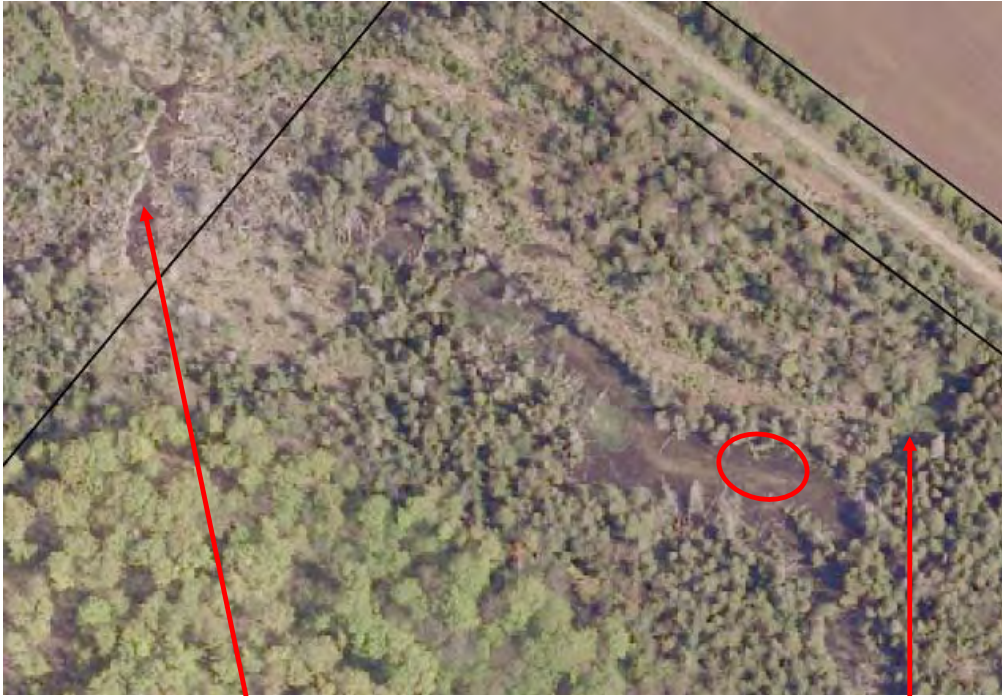
No other congregations of trout were observed until the survey crew was within 50m of Jack's Jaunt. Approximately 8-12 spawning size brook trout were observed in the slow deep section of the reclaimed channel upstream of the old beaver pond and blowdown area. This section has been undergoing restoration work over the last two summers and has redefined a deeper, narrower and cobble bottomed channel through the old mud flats of the old beaver pond. Figure 5 shows the location of the congregation of trout in relation to the old beaver pond that has been breached and the little spring at Jack's Jaunt that has been recently opened. The new spring has been tentatively named Joanne's Joy. There may be a potential and opportunity for additional spawning bed development in this area. The placement of spawning gravel over the springs at the top of Joanne's Joy was discussed as a possible project for this coming year.

Figure 5: Pre-restoration air photo of section of Armstrong Creek upstream of old beaver dam and downstream of restored spring. Spring tentatively called Joanne's Joy. Location of trout congregation is circled in red.

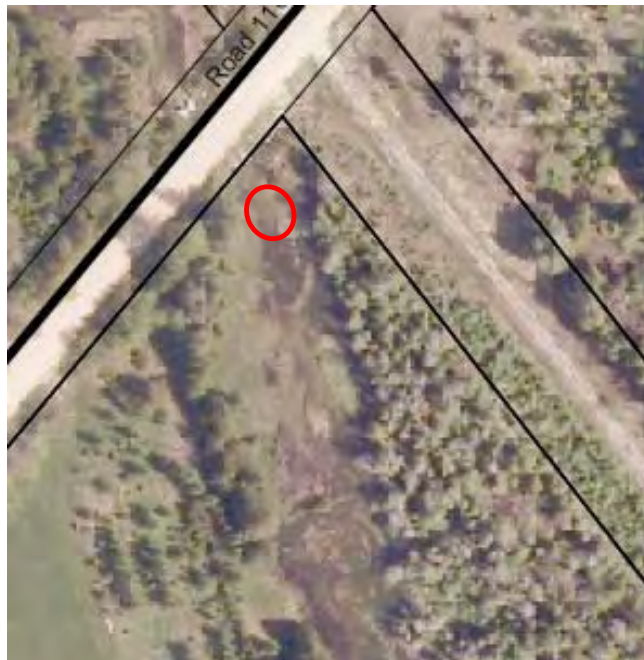
No further evidence of redds or brook trout congregations were observed until the section of channel just upstream of Rd. 110 (Figure 6 and Table 1). A portion of the channel has been deepened approximately 40m upstream of the culverts. It was in the deepest portion of the channel (approx. 35cm deep) that approximately 6-10 mature brook trout were observed. This is the same general location as the site of previous noted spawning several years ago (2006 D'Amelio pers. comm.).

Figure 6: Location of last brook trout congregation noted during survey.
